TENNESSEE DEPARTMENT OF TRANSPORTATION
EROSION PREVENTION/SEDIMENT CONTROL
INSPECTION REPORT

DATE: 5.12.11

State Route (SR) / US Route or Road Name and Description:			Are corrective actions required by this inspection report (Y/N):			
Wolf River Blvd.			YES			
County(ies):	TDOT PIN:	NPDES Permit (NOC) #:	Number of New Corrective Actions:	Number of Recurring Corrective Actions:	Number of New Sediment Releases:	Number of Un-Corrected Sediment Releases:
Shelby	101615	TNR153299				
TDOT Construction No.:	TDOT Contract No.:	Contractor:	0	1	0	0
7994-1535-54		Acuff Enterprises Inc.

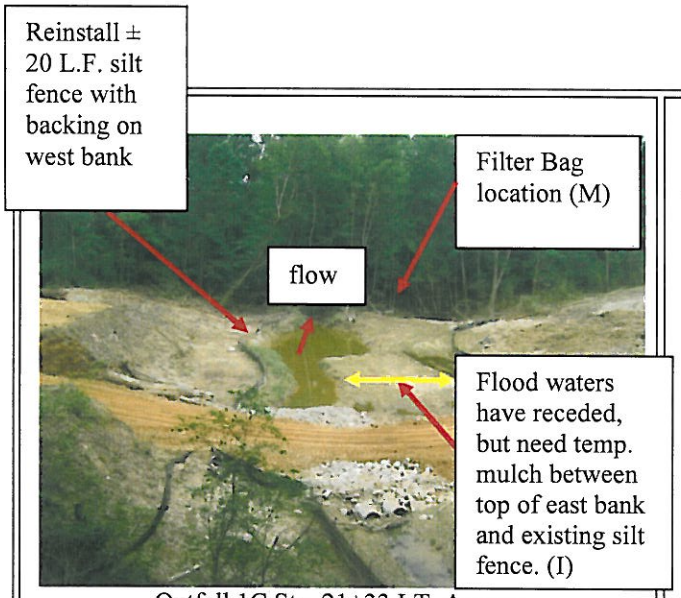
Outfall Name or Station No.	Rain Gage No.	Approx. Station No. From / To	LT, RT or Centerline	Date Last Disturbed	Date of Stablilization and Code T = Temp. P = Perm.	Existing EPSC Control Measure Codes*	Current Condition Codes*	Corrective Action(s) or Comments
1	1	14+14	LT				S	OUTFALL STABLE NO CURRENT ACTIVITY
1A	1	21+50						
1B	1	22+00						
1C	1	21+00	LT	4/21/2011		10	M	No Change @ this time. Repeat Occurrence (see photo, page 5 of 5)
2A	1	33+50						
2B	1	35+50						
3	1	34+50						
4	1	40+00						
5A	1	49+00						
5B	1	50+00

Outfall 1C Sta. 21+33 LT. Approx.
Corrections are needed as indicated.
(I)(M)
