TENNESSEE DEPARTMENT OF TRANSPORTATION
EROSION PREVENTION/SEDIMENT CONTROL INSPECTION REPORT

DATE: 7-18-11

State Route (SR) / US Route or Road Name and Description:			Are corrective actions required by this inspection report (Y/N):			
Wolf River Blvd.			YES			
County(ies):	TDOT PIN:	NPDES Permit (NOC) #:	Number of New Corrective Actions:	Number of Recurring Corrective Actions:	Number of New Sediment Releases:	Number of Un-Corrected Sediment Releases:
Shelby	101615	TNR153299				
TDOT Construction No.:	TDOT Contract No.:	Contractor:	1	5		
7994-1535-54		Acuff Enterprises Inc.

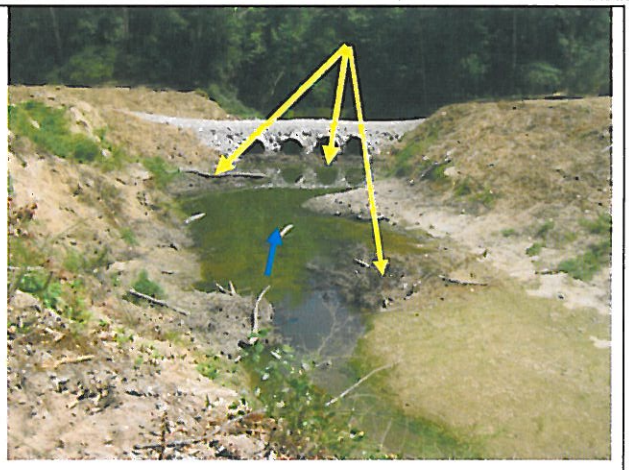
Outfall 2B Sta. 35+50 LT
Remove felled trees and debris from stream.
(I,RO)
