TENNESSEE DEPARTMENT OF TRANSPORTATION
EROSION PREVENTION/SEDIMENT CONTROL
INSPECTION REPORT

DATE: 4.23.12

State Route (SR) / US Route or Road Name and Description:			Are corrective actions required by this inspection report (Y/N):			
WOLF RIVER BLVD.			YES			
County(ies):	TDOT PIN:	NPDES Permit (NOC) #:	Number of New Corrective Actions:	Number of Recurring Corrective Actions:	Number of New Sediment Releases:	Number of Un-Corrected Sediment Releases:
Shelby	101615	TNR153299	0	3		
TDOT Construction No.:	TDOT Contract No.:	Contractor:				
7994-1535-54		Acuff Enterprises Inc.

State/US Route or Road Name: Wolf River Blvd. TDOT Construction No.: 79954-3537-54 TDOT Contract No.: _____

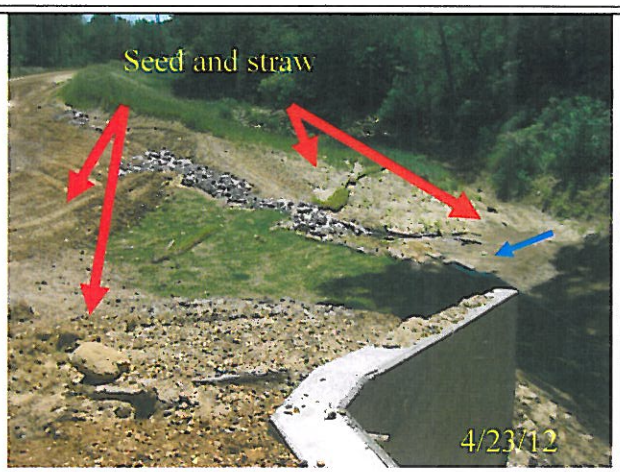
Outfall 1B Sta. 22+00 RT
Seed and straw areas as noted in photo. (FM)

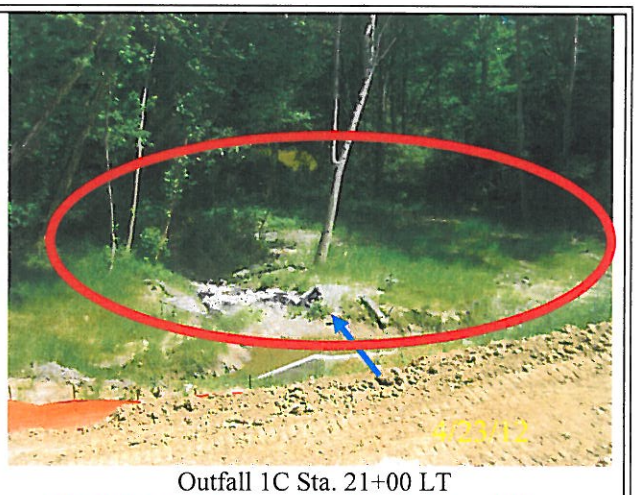
Outfall 1C Sta. 21+00 LT
Maintenance require on outfall structure. (M)

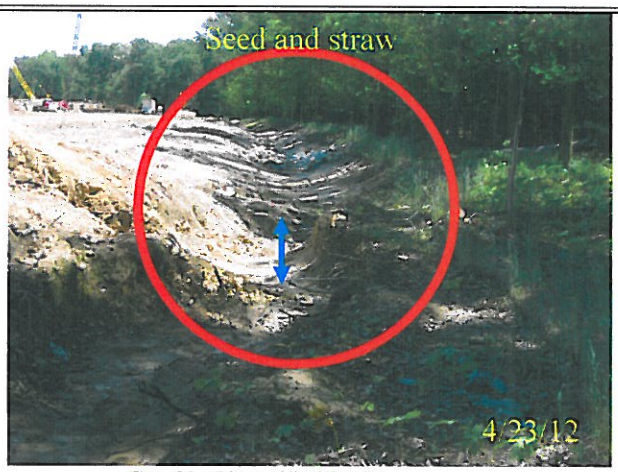
Sta.61+50 to 65+80 RT
Temp. stabilization as required. (FM)
